SAFETY IMPACT STUDY OF CENTERLINE RUMBLE STRIPS IN GEORGIA

A Thesis
Presented to
The Academic Faculty

In Partial Fulfillment
of the Requirements for the Degree
Master of Science in the
School of Civil and Environmental Engineering

Georgia Institute of Technology
May 2014

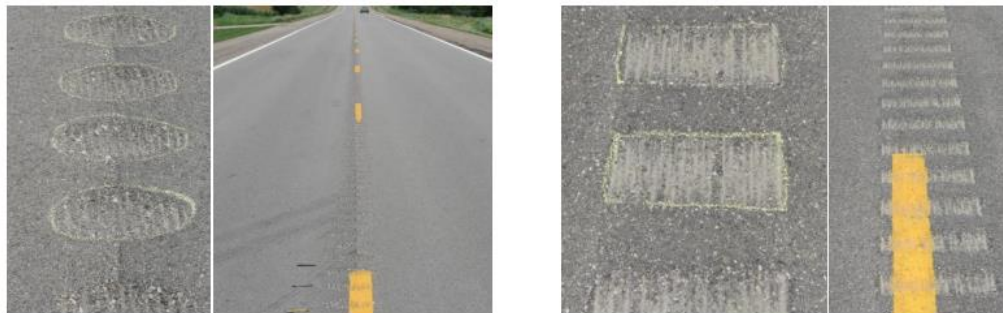
Figure 2: Patterns of Milled-in Centerline Rumble Strips, from left to right: Football-shaped, Rectangular-shaped [42]

Milled-in rumble strips, also known as ground-in rumble strips, are cut into the road surface by a machine with a cutting head [7]. These grinding machines can grind up to 1.25 miles per hour, and carves out regular indentations on roadway independent of the roadway age [34]. The repetitive milling of the roadway creates smooth, uniform, and consistent grooves in the pavement surface in one of two shapes: football shaped or rectangular shaped (Figure 2). In terms of safety benefits, no statistical differences between the two shapes have been found [42].
